AIR FORCE WEAPONS LAB KIRTLAND AFB NM
MAINTAINING THE INTEGRITY OF THE TRESTLE DECKING.(U)
JUL 82 D S MCKNIGHT
AFWL-TR-82-29

MAINTAINING THE INTEGRITY OF THE TRESTLE DECKING

Final Report

AIR FORCE WEAPONS LABORATORY
Air Force Systems Command
Kirtland Air Force Base, NM 87117

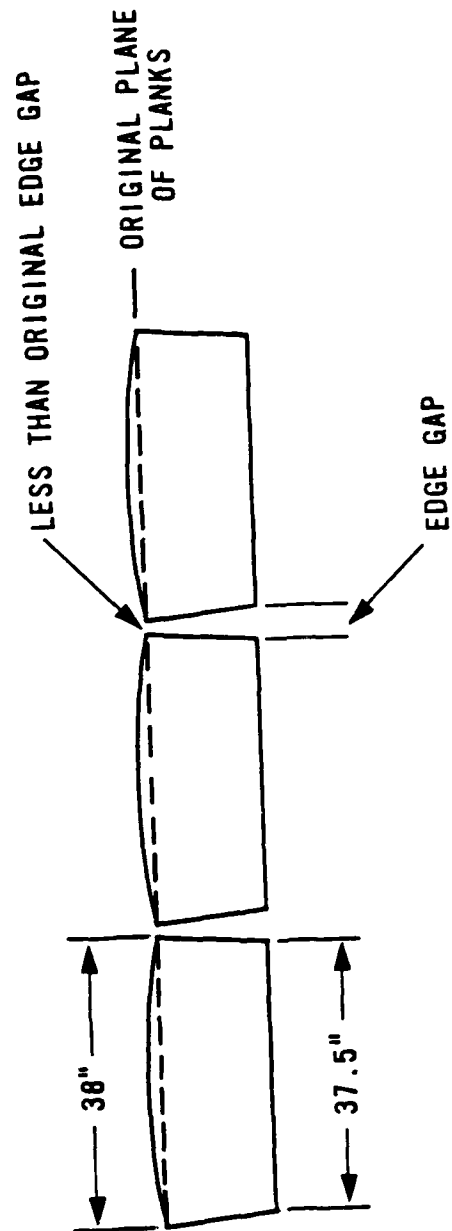
Figure 5. Representation of plank crowning.

stresses are also a direct result of moisture gradients alone. This expansion of the planks is more prominent on the top lamination resulting in a crowned appearance of the planks. The plank appears crowned because the moisture content of the wood is higher near the middle of the plank than near the edge gaps (Fig. 5). This crowned nature has actually aided in the runoff of water from the decking as long as the edge gap remains.

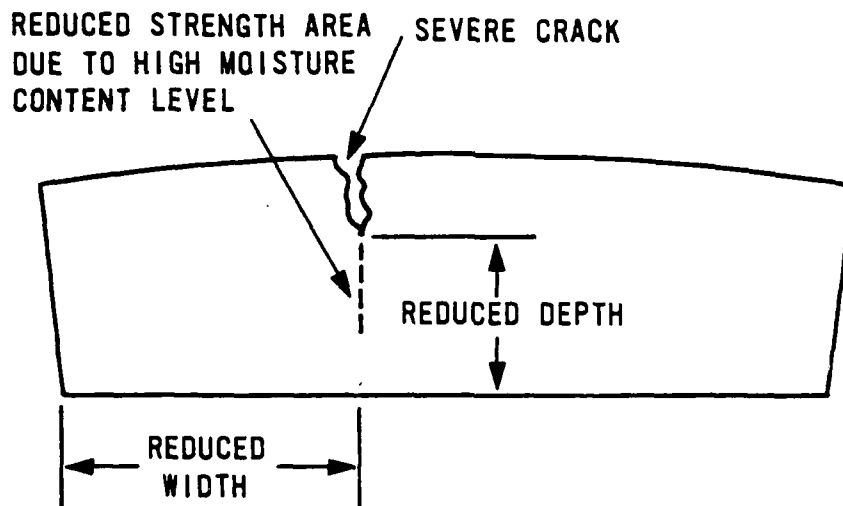
Figure 6. Severe crack - worst case.

Severe cracking (Fig. 6) has occurred in some areas. When surface cracks that are large enough to crack the coating developed, and a new coating is not applied immediately, water collects in these cracks. Absorption of this water causes it to further expand and crack, resulting in still more absorption, expansion, and cracking. In addition, when the wood expands it initially closes the crack and makes it more difficult for it to dry. If this problem is ignored, it could (and may) cause major structural problems by changing the decking's characteristics. Minor cracking and aging are expected and accounted for in determining the platform strength. Prompt maintenance and repair of these cracks will prevent severe cracking and extend the useful life of TRESTLE immeasurably. The severe cracking is a major concern that could greatly reduce the decking's strength.

As shown in Figure 6, a severe crack could eventually separate a plank into two or more smaller planks. The reduced strength area includes only a

portion of the remaining cross section. The variation of the moisture content with depth is an unknown factor which needs to be investigated by an additional study. The depth of the increased moisture content is minimized since glue lines every $1 \frac{5}{8}$ in helps to prevent the seepage of moisture. As a result, the higher moisture content levels of the upper laminations in contrast to the drier lower laminations cause high shear between these laminations.

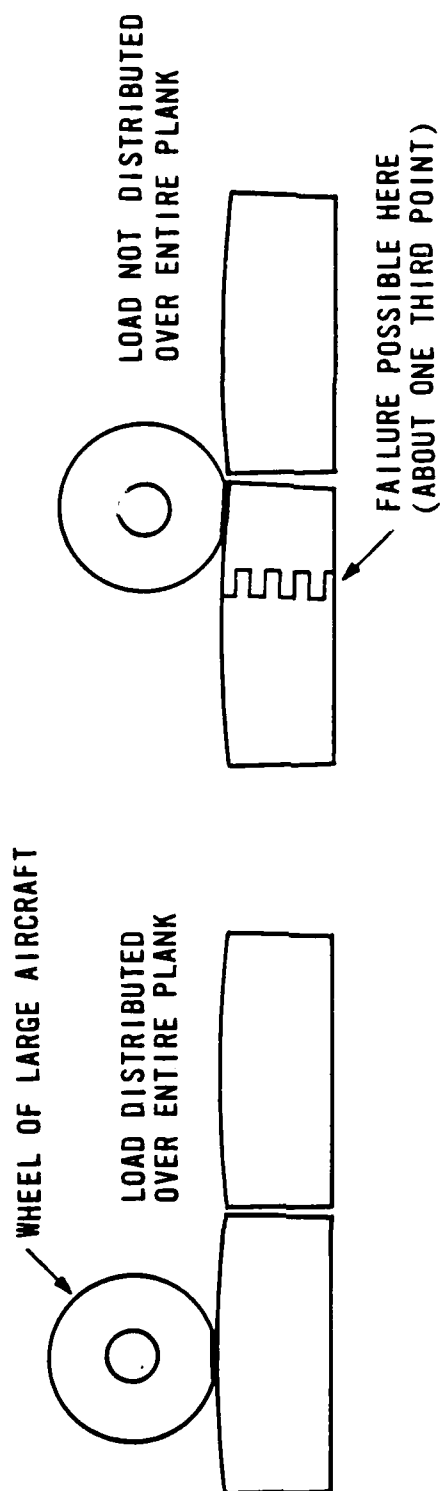
Figure 7. Reason for distributor beams.

Plank separation may result from a severe crack alone or from a large crack which is ripped open (dotted line in Fig. 7) when loaded. The possibility of this rip occurring is increased because where the depth is reduced, the strength of the wood is also reduced, due to the higher moisture content (Table 2). Readings taken on TRESTLE show that the moisture content varies across the cross section of the plank. It is higher on the top and lower on the underside of the planks. In fact, the underside of the planks showed moisture content levels of less than 7 percent. These readings were taken as part of Experiment 1A. These two factors, reduced strength and reduced dimen-

sions, make this area a candidate for failure in horizontal tension (shear)* which would cause one plank to act as two. This phenomena actually occurred in tests conducted on TRESTLE deck planks at the Portland Cement Laboratories in Skokie, Illinois.** The width of the deck planks is an important number in calculating the deck strength. If a severe crack causes one deck plank to act as two planks at half the width, then each of the two new deck planks are at best half as strong as the original one. This is a worst case analysis, but entirely possible, if nothing is done to alter the problems.

It should be noted at this point that the distributor beams were added to the TRESTLE to prevent plank separation, caused by horizontal tension. This is a direct result of combined bending and torsion due to undistributed loading. The builders and designers of TRESTLE feared that as the weight of the aircraft was shifted from one plank to another there was the possibility of one of the planks becoming separated into two. Figure 7 shows what theoretically could happen.

The first plank is loaded unsymmetrically which results in combined bending and torsion on this plank. It is the horizontal tension due to torsion which causes separation. This fracture results because the cross grain tensile strength of the wood is quite low. The distributor beams were added to help prevent this from happening. If the distributor beams are present and intact, the possibility of failure due to horizontal tension is nonexistent. For this reason a study concerning the maintenance of the distributor beams should be done as an addition to this study.

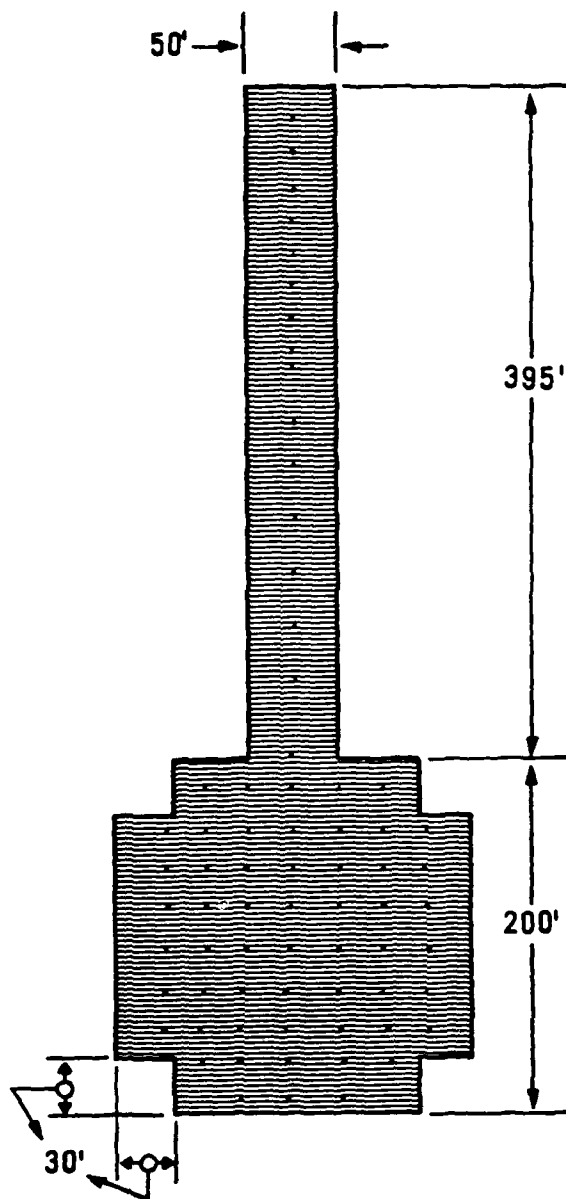
Figure F1. Gridwork

During this experiment, 200 moisture content readings were taken at 71 test areas on the platform decking. This gridwork was used as a means to verify the accuracy of the readings taken periodically at the five test areas of interest. The gridwork of these 71 test areas and the readings taken at each area are located in Appendix F.

At test areas 5, 9, and 56 moisture content measurements were taken that went well above 40 percent. It should be noted that the moisture content reading device does not function well over the 40 percent level.
